THE WRECK OF
THE SS
RICHARD MONTGOMERY

A SUMMARY REPORT
The COASTGUARD Agency
an Executive Agency of the
Department of Environment, Transport and the Regions

29 September 1997

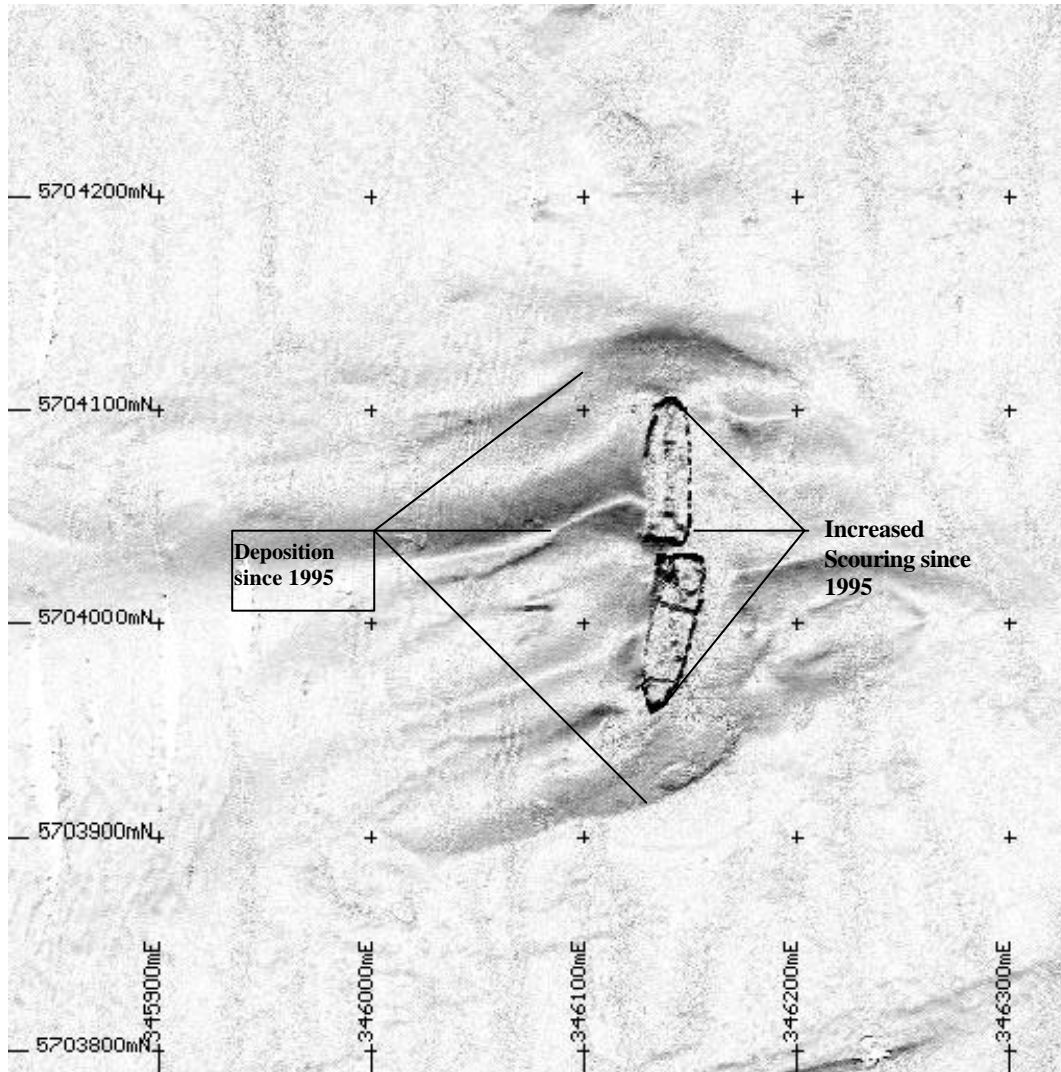
MONOCHROMATIC GRADIENT PLOT

A monochromatic gradient plot at ANNEX C reveals details of the ship's structure. This plot also reveals details of small seabed topographical features such as sand ripples over the area.

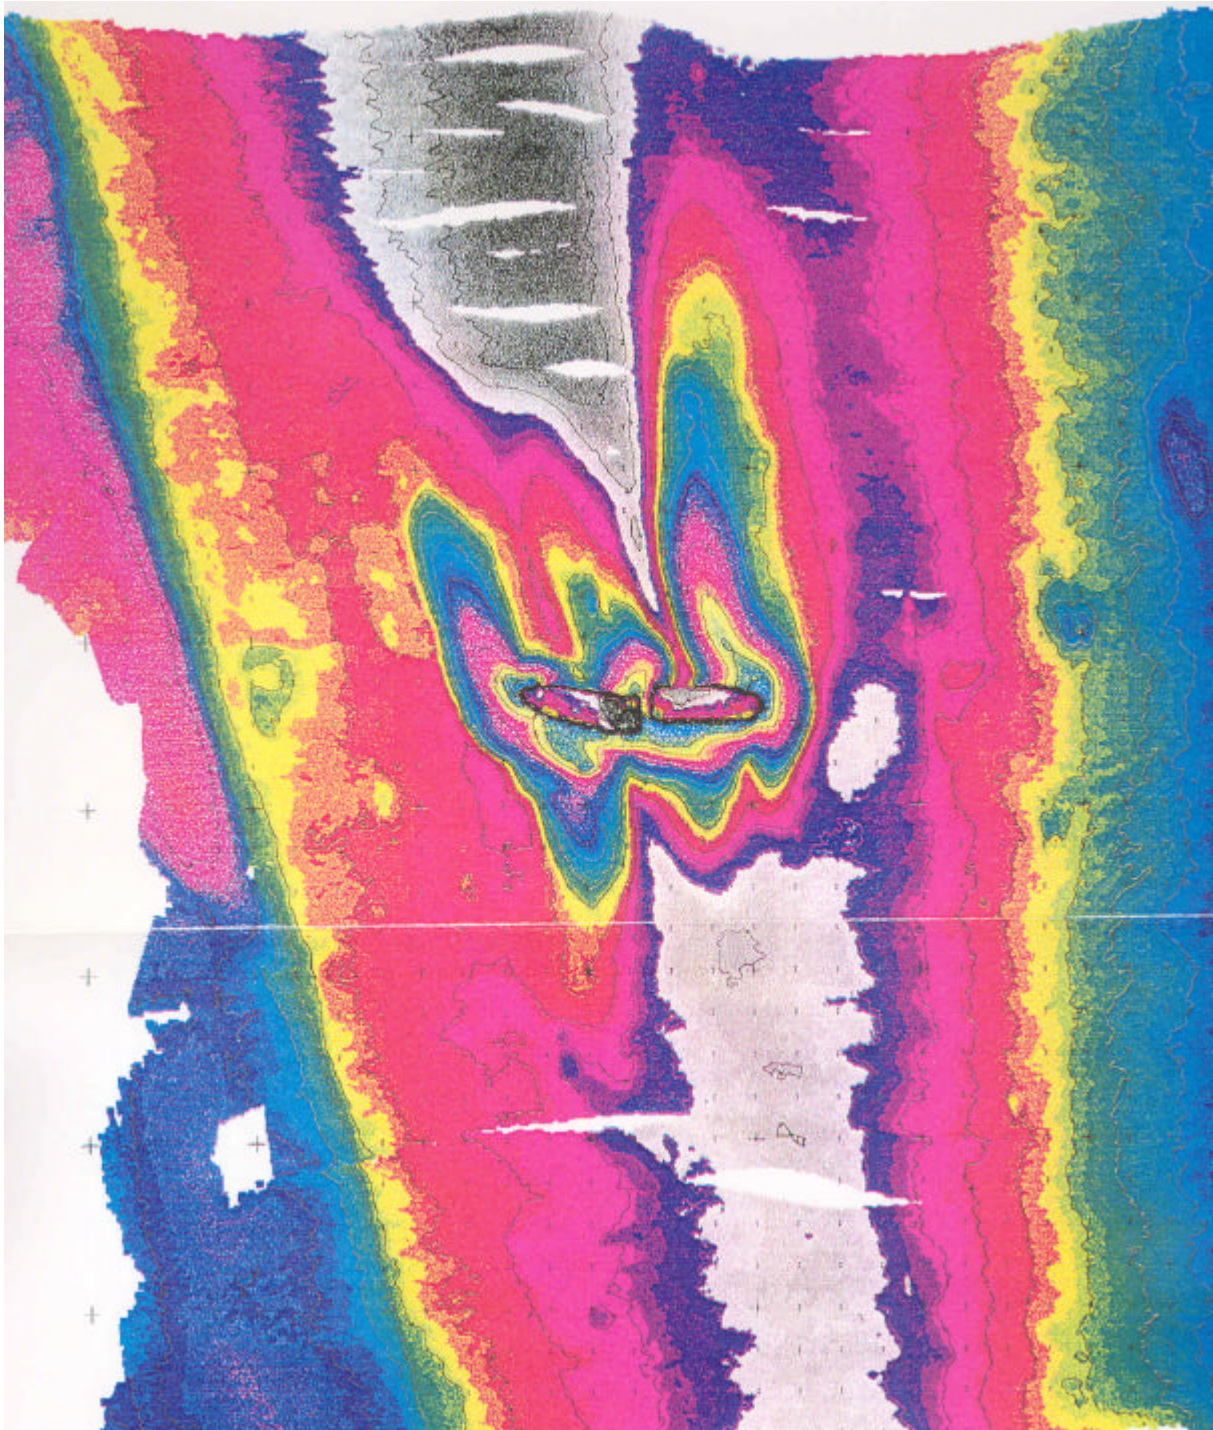
The following features within the survey area may be observed from the solid contour plot (ANNEX D):

No significant changes in position or orientation of the wreck were observed as a result of the 1996 survey. From the comparison plot and contour plots it could be seen that the depth of scouring to the east of the wreck site had increased markedly almost along the entire length of the wreck, reaching maxima at the break and at the bow and stern. It was also noteworthy that some deposition had occurred to the west of the wreck at the centre of the forward section. This deposition could be seen as an extension of the western part of the Sheerness Middle Sand.
